Complex Equipment Repair Ensures Uninterrupted Operations

WesTech's Novel Solution Addresses Unusual Tank Corrosion

Location
Southeastern United States

Owner
Power Utility Company

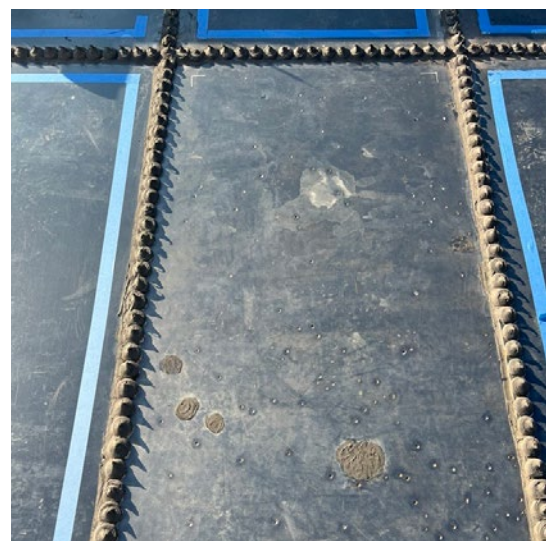
While inspecting four discharge tanks and one feed tank, we discovered an unusual corrosion pattern based on the location. After just two years, the glass-lined, 1.1-million-gallon tanks had a random array of corroded spots in the middle of the four-foot panels rather than just on bolts or joining points.

Close-up view of the corrosion on the panels inside the tank.

A joint effort between several WesTech teams got underway to enable the utility to meet its discharge targets. Thanks to the expertise of our on-site staff, we landed on using a Chevron Industrial Membrane (CIM) elastomer-type epoxy from Chase Corporation. We believed that this would be durable enough to treat the corrosion and stop holes from forming in the tanks.

We had to meticulously clean the tanks, apply the first layer of the epoxy, let them dry, and recoat. Based on this process, we worked closely with Chase Corporation to dial in the CIM formula so that it could withstand all of the variables while sealing off the corrosion for long-term use. Once we had the right mix, we successfully used the epoxy on two of the discharge tanks before temperatures dropped in the Southeast for winter.

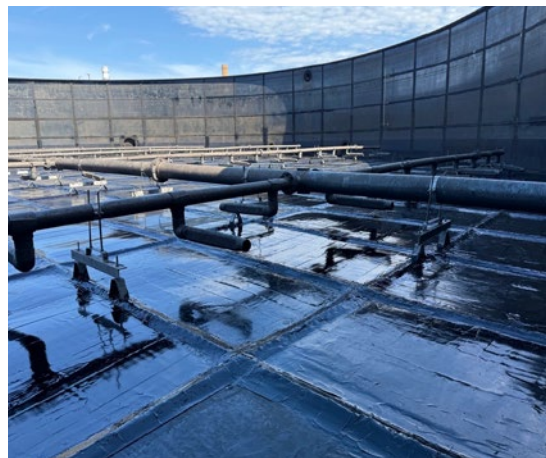
View from inside tanks after application of Chevron Industrial Membrane (CIM) elastomer-type epoxy is completed.

We managed to solve what seemed to be an unsolvable problem for our customer. Even without upfront insight into the exact issue, we repaired the glass-lined tanks efficiently with no interruption to the plant's treatment processes. The tanks were reexamined a few months later and the solution proved successful and durable.

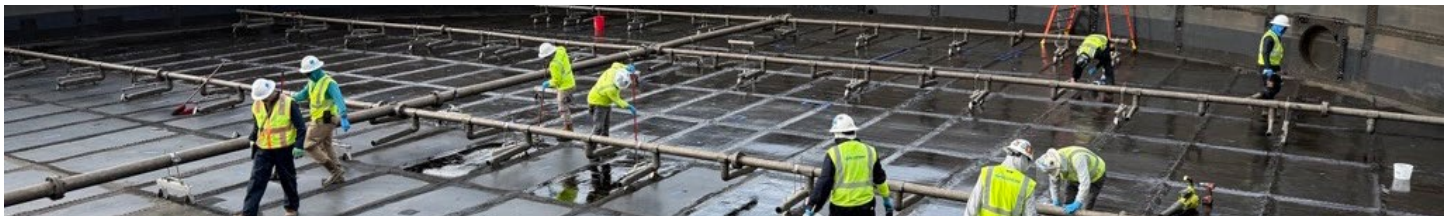
The operations crew meticulously applying the CIM formula to repair tank corrosion, ensuring the tank's long-term integrity.

Fixing the problem wasn't easy. The CIM product required a controlled application environment, which was difficult to achieve in an open field. For example, tank temperatures fluctuated a lot and could reach up to 170 degrees when mostly empty.
