Adsorption Clarifier® Retrofit Improves Plant Operations Westfield Updates Existing Trident® Package Plant

Case Study

Westfield, New York

Village of Westfield-Benjamin
Schwartz Water Treatment Plant

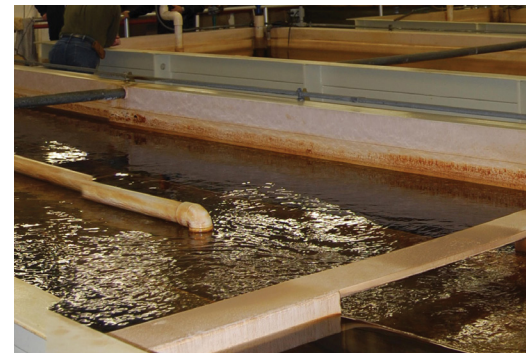
Twenty-one years in operation had taken a toll on the original system.

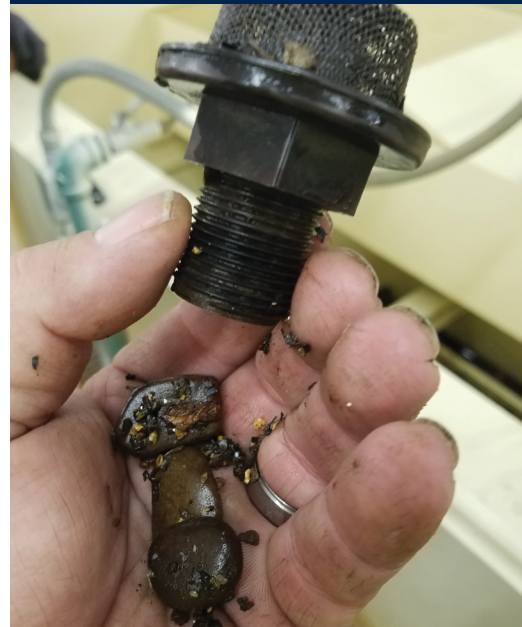
Replacing plugged Adsorption Clarifier nozzles enhanced performance.

Because the plant often operates two units with the third in standby, the implementation team opted to perform the upgrades sequentially, one unit at a time (always leaving two units operational). The repairs included replacing the Adsorption Clarifiers' media and inspecting their air distribution system. The team also repaired or replaced nozzles (as needed), static mixers, and filter inlet and effluent function valves.

- Replacing the plugged air nozzles in the Adsorption Clarifier compartment allowed the flush process to better clean the buoyant media across the entire bed.
- Upgrading the filter section with an air-water backwashing system improved the performance of the filters, providing a more rigorous and thorough bed turnover that releases more solids contained in the bed.

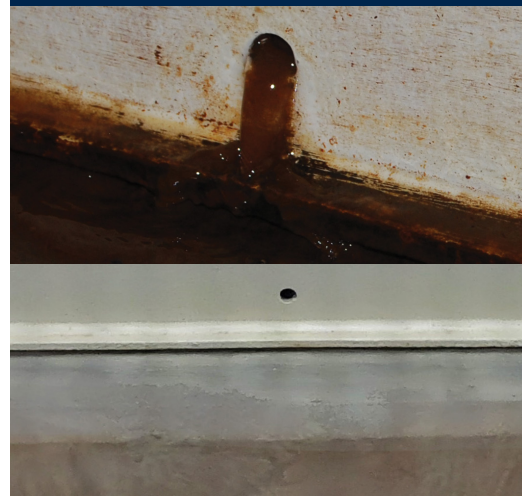
The first step was to find out why water and media were leaking from the weep holes on both sides of the double wall between a unit's clarifier and filter compartments. Applying air pressure through the openings while the filter and clarifier compartments were full of water revealed that the leak was coming from the clarifier compartment.

ferric chloride as a coagulant with cationic polymer and carbon. The raw water and chemistry, which contain abrasive particles, entered the Adsorption Clarifier compartment through a raw-water header and was constantly hitting the double wall between the clarifier and filter. Over the years, this had worn a hole through the first wall.

Normally 48 inches (1.2 meters) deep, Adsorption Clarifier media loss had reduced the actual bed depth to approximately 24 inches (0.6 meters), resulting in lower solids retention. Solids that should have been captured in the Adsorption Clarifier media were passing to the filter, resulting in short run times between backwashes.

The Adsorption Clarifier media coming out of the weep holes was indicative of media coated with a material that was not allowing it to retain its buoyancy. Finally, the unit's surface-only wash was not thoroughly cleaning the filter bed.

Adsorption Clarifier buoyant media had been leaking from the unit's weep hole.

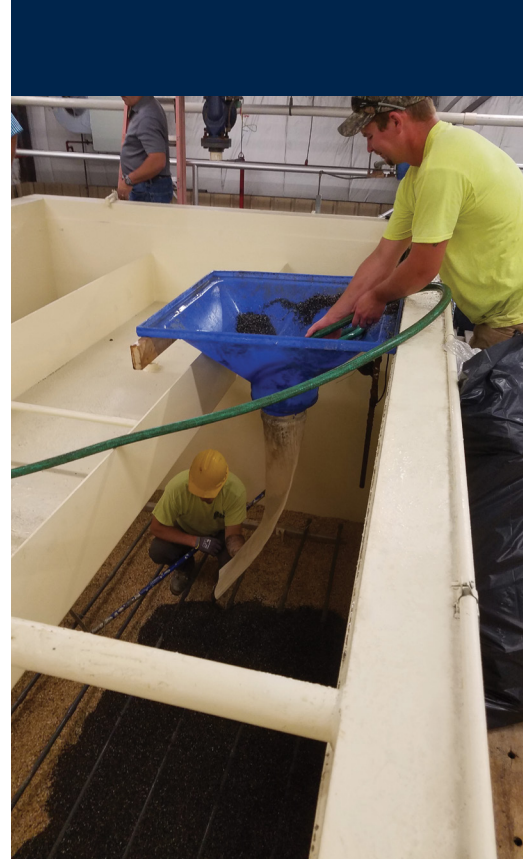
Filter bed media was installed atop the new in-bed air grid for air-water backwashing.

- Removing the existing surface wash arms, filter media, and support gravel
- Inspecting the existing header and lateral underdrain
- Replacing the support gravel
- Adding an in-bed air wash grid
- Replacing the filter media
- Adding (or replacing) the existing blowers
- Adding air scour valves

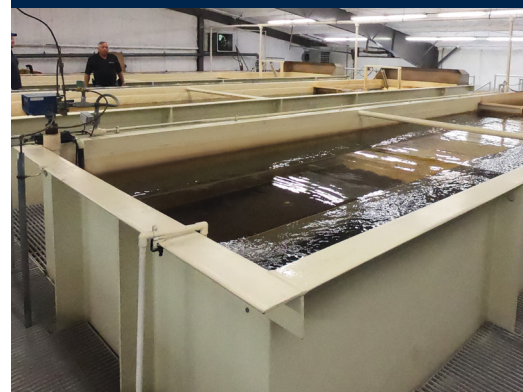
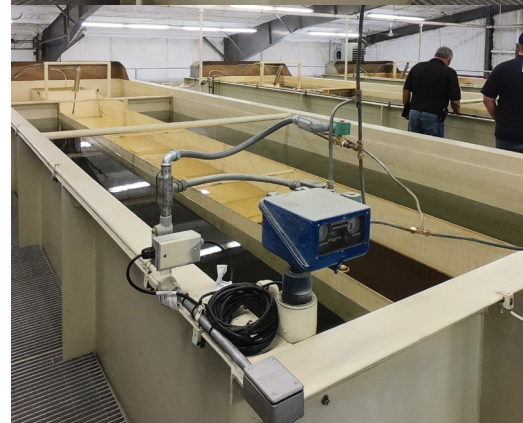
The plant repaired and painted the tanks during the repair-upgrade process. The three updated Westfield units are now in production.

While each unit was down, the plant repaired and repainted the tanks. It completed the repairs and upgrades in 2019.

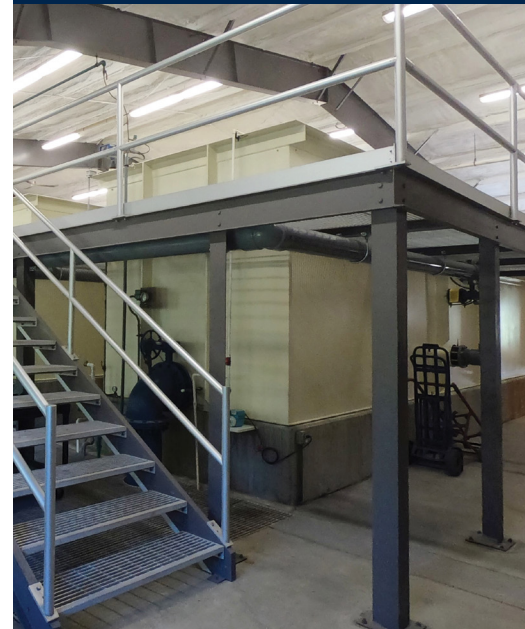
Simple but necessary upgrades to the Trident system improved plant efficiency.
